AEDC-TR-68-23

## **EFFECT OF CONTAMINATION ON SPACECRAFT SURFACES EXPOSED TO ROCKET EXHAUSTS**

**TECHNICAL REPORTS** B. A. Burch  
**FILE COPY** ARO, Inc.

**April 1968**

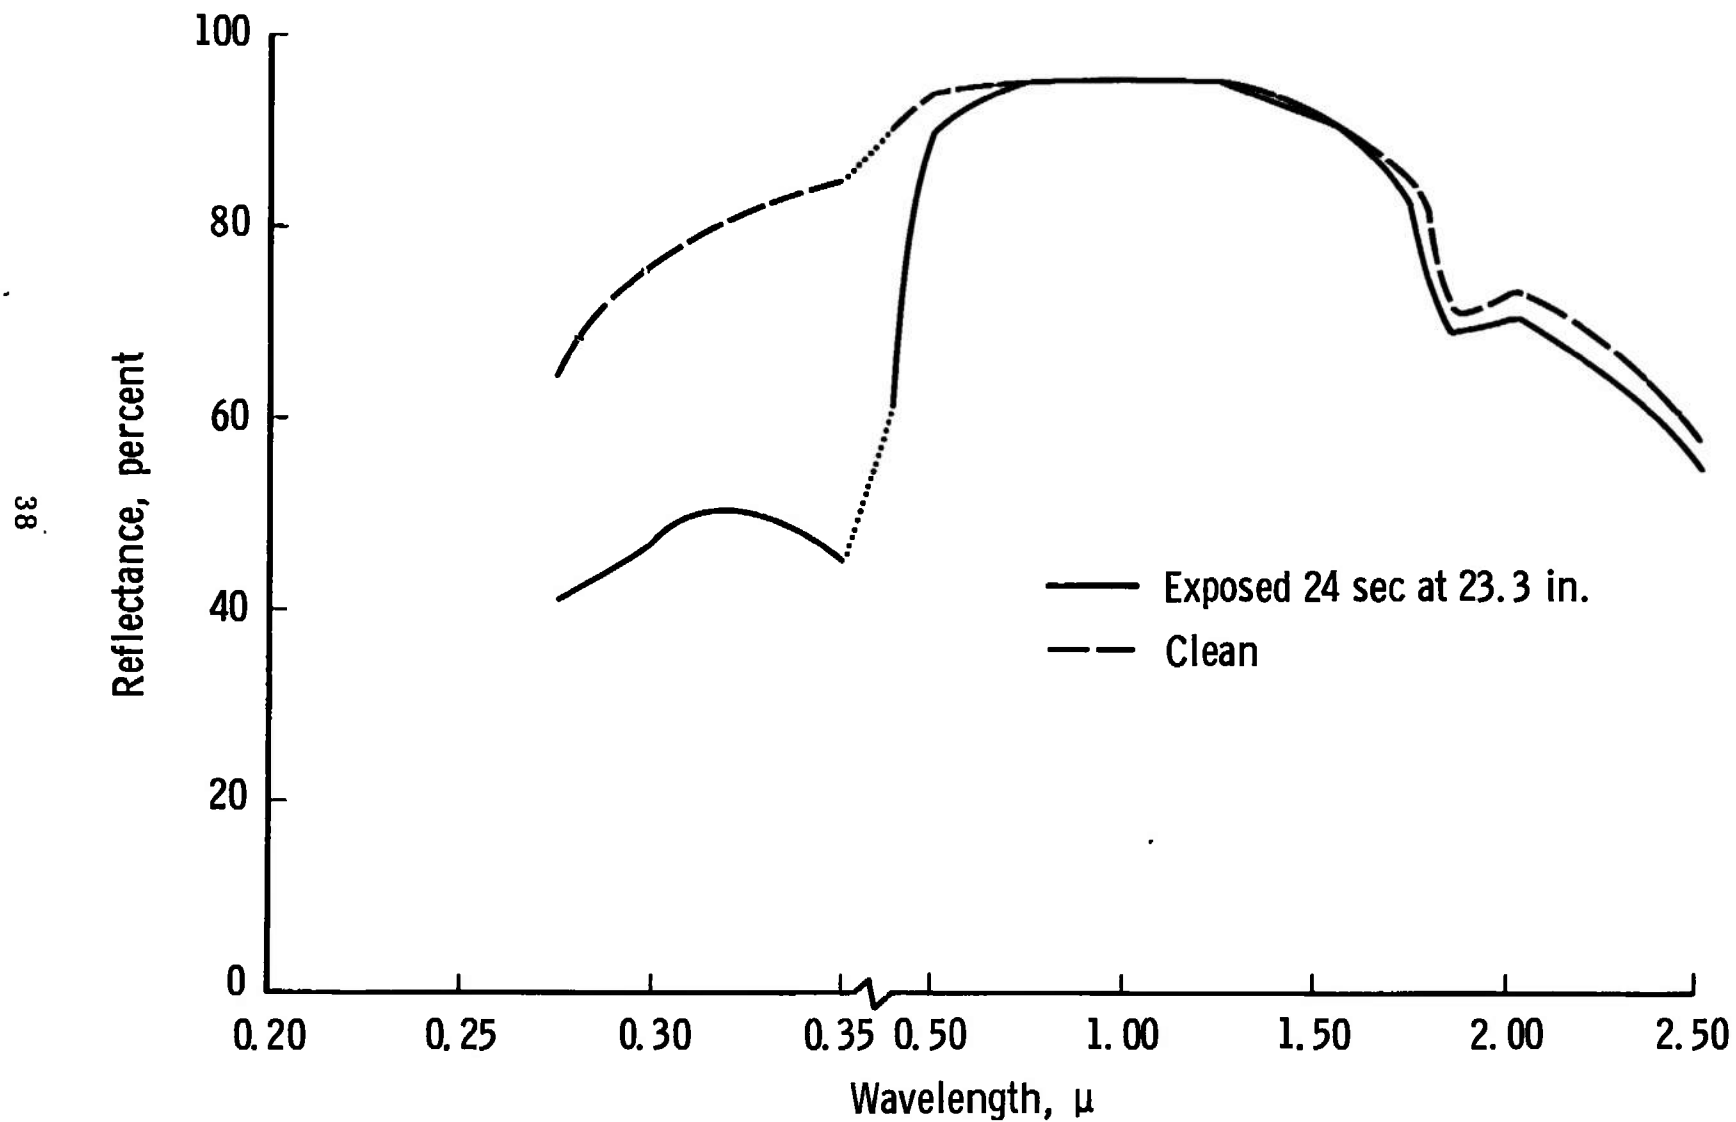
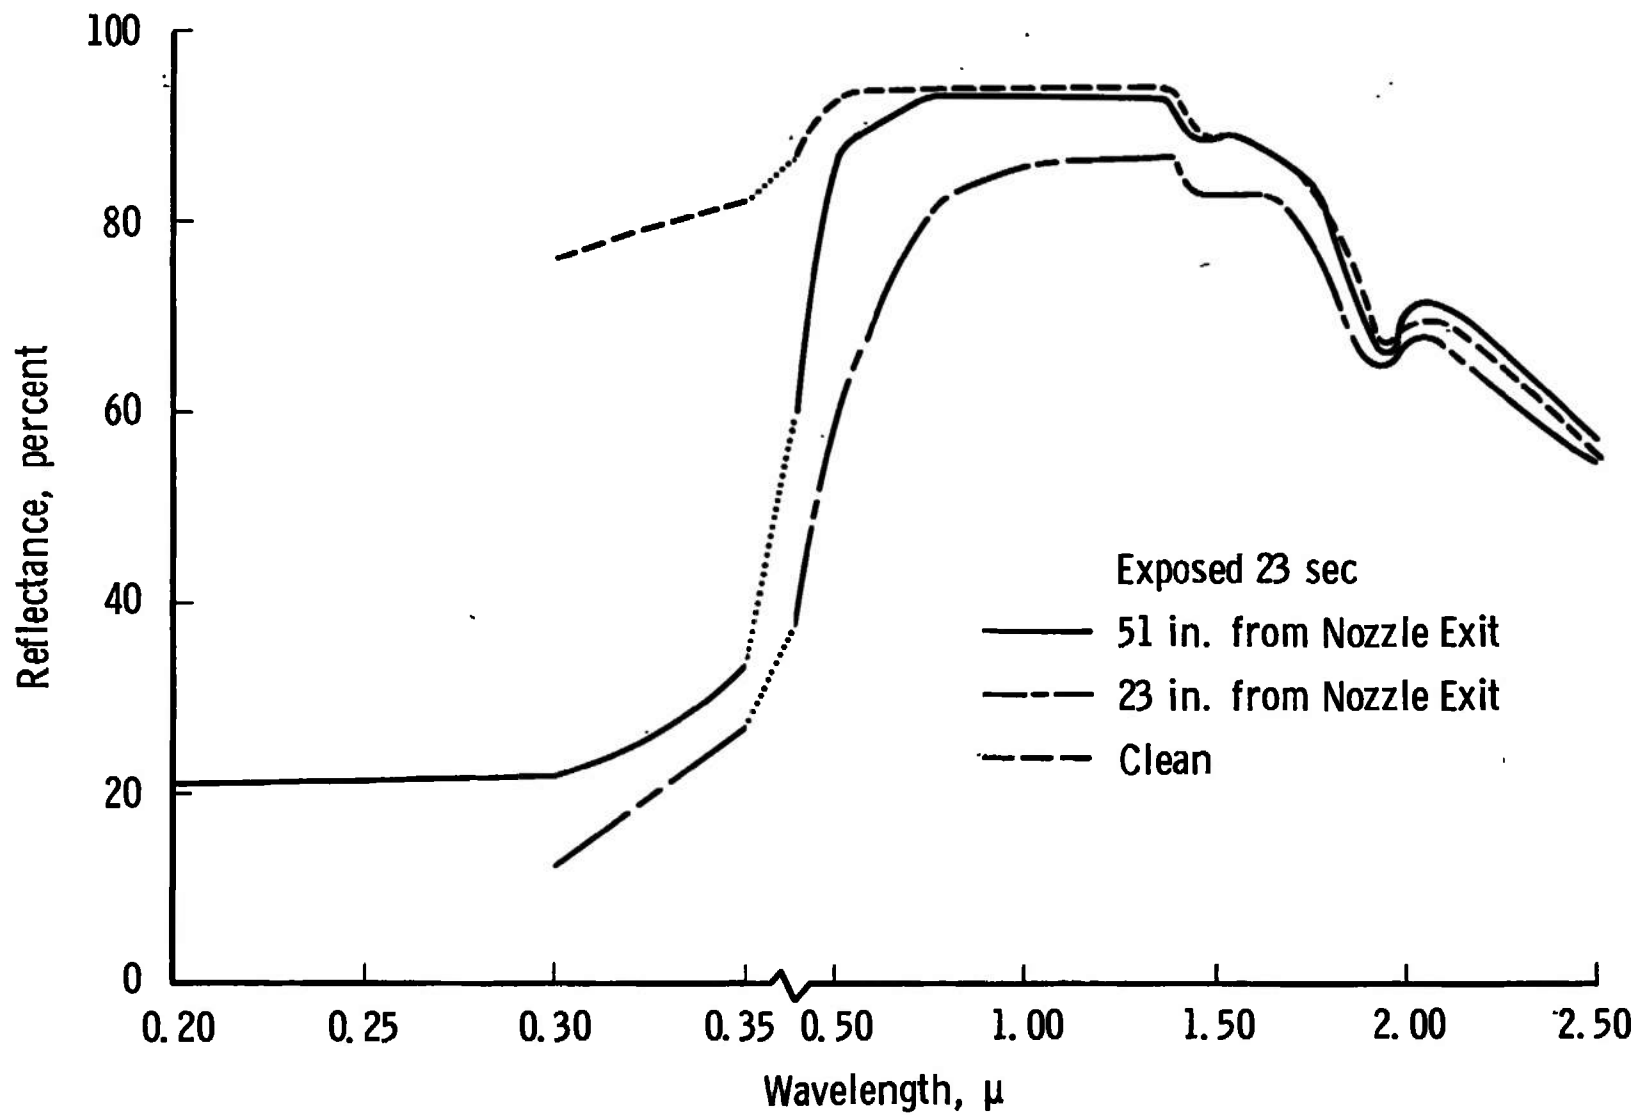
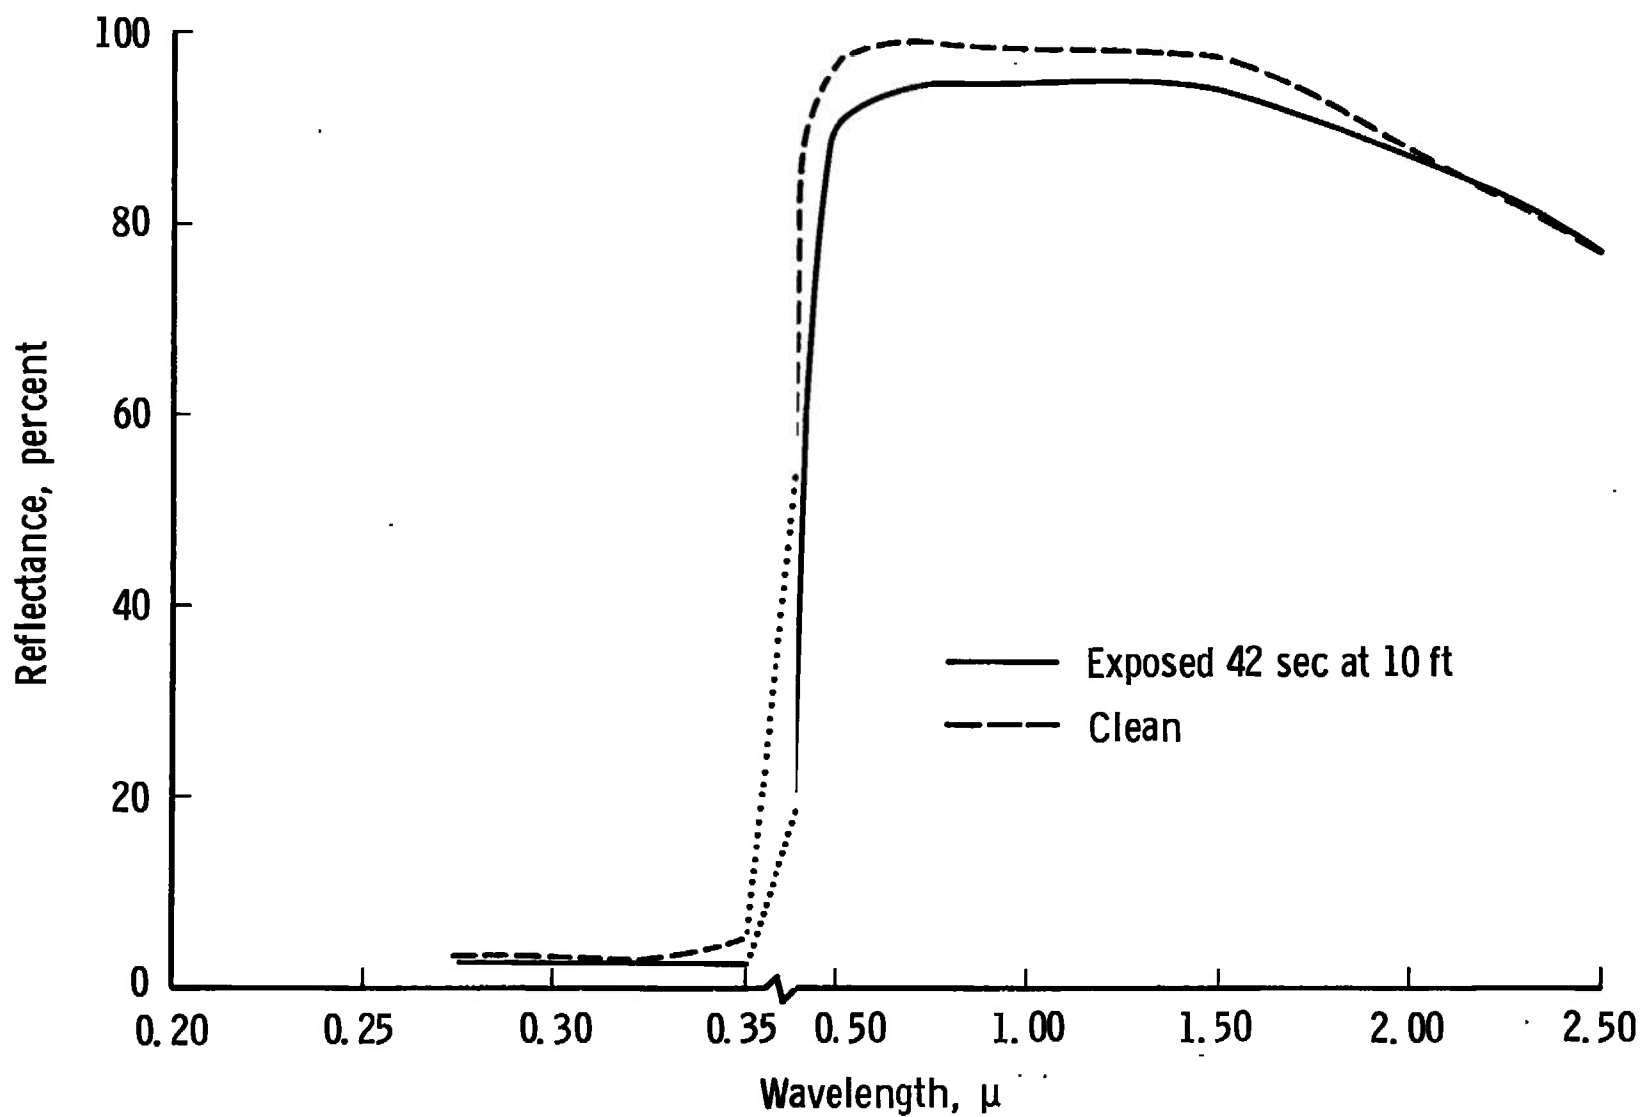
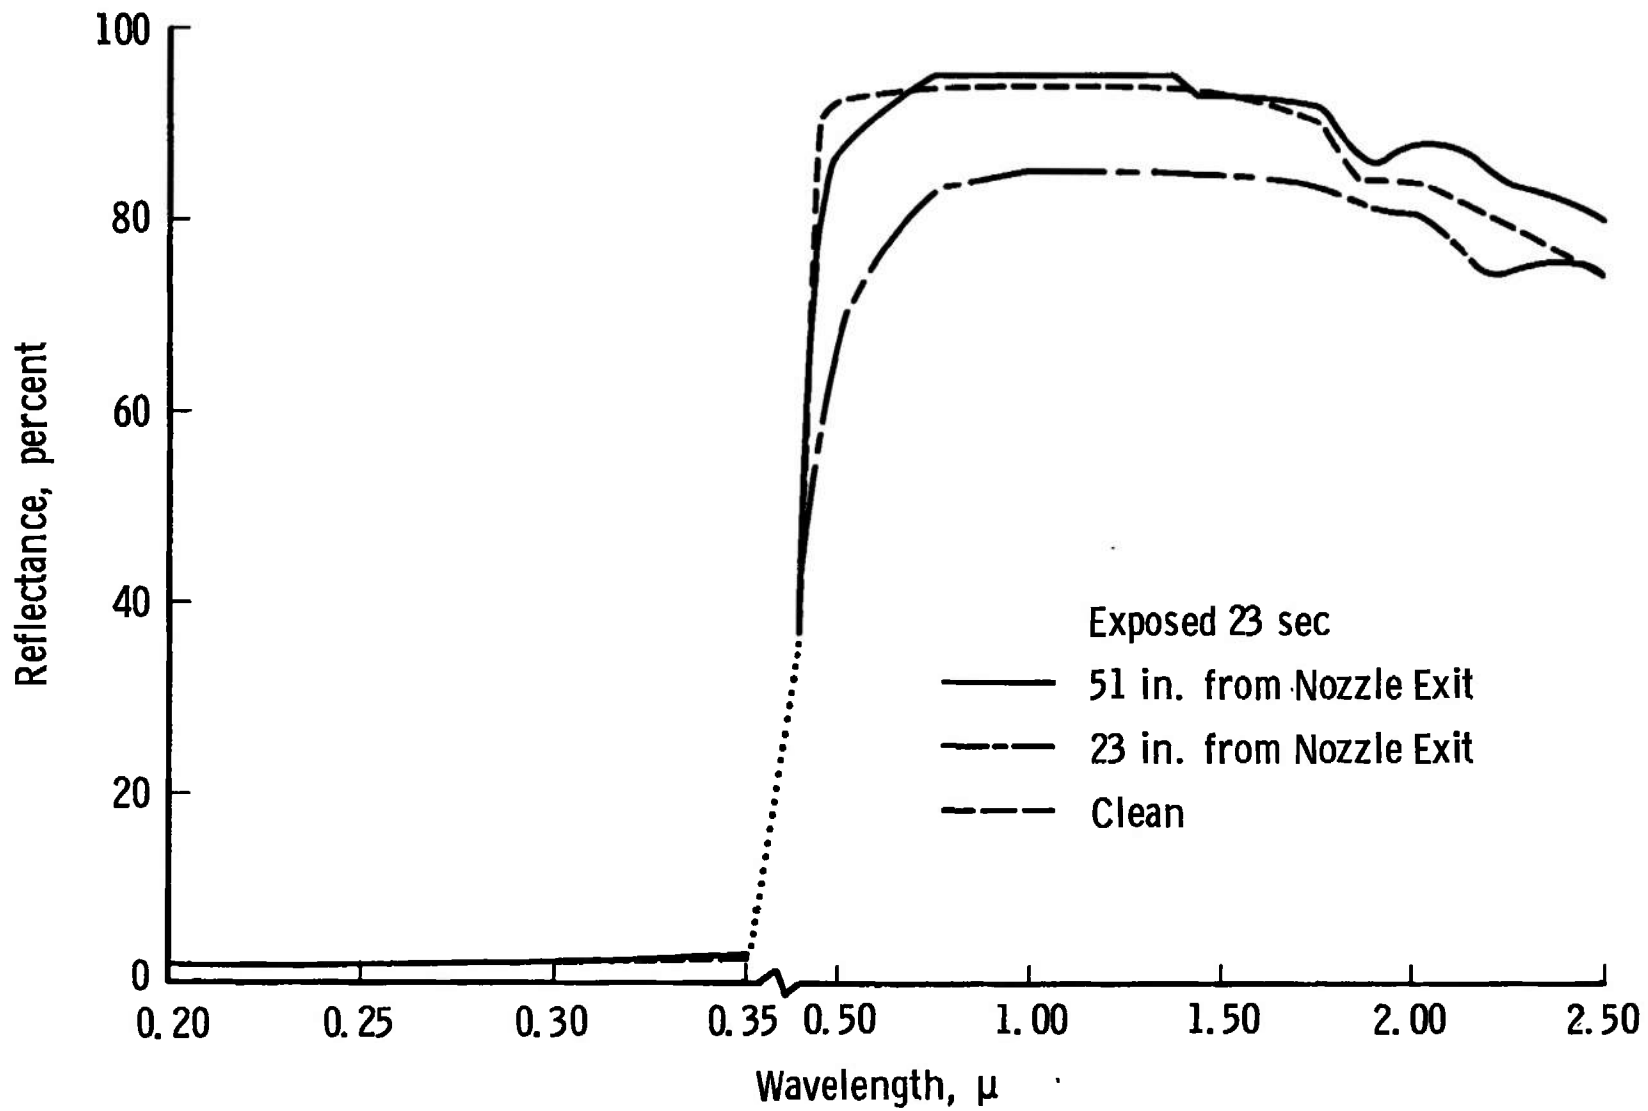
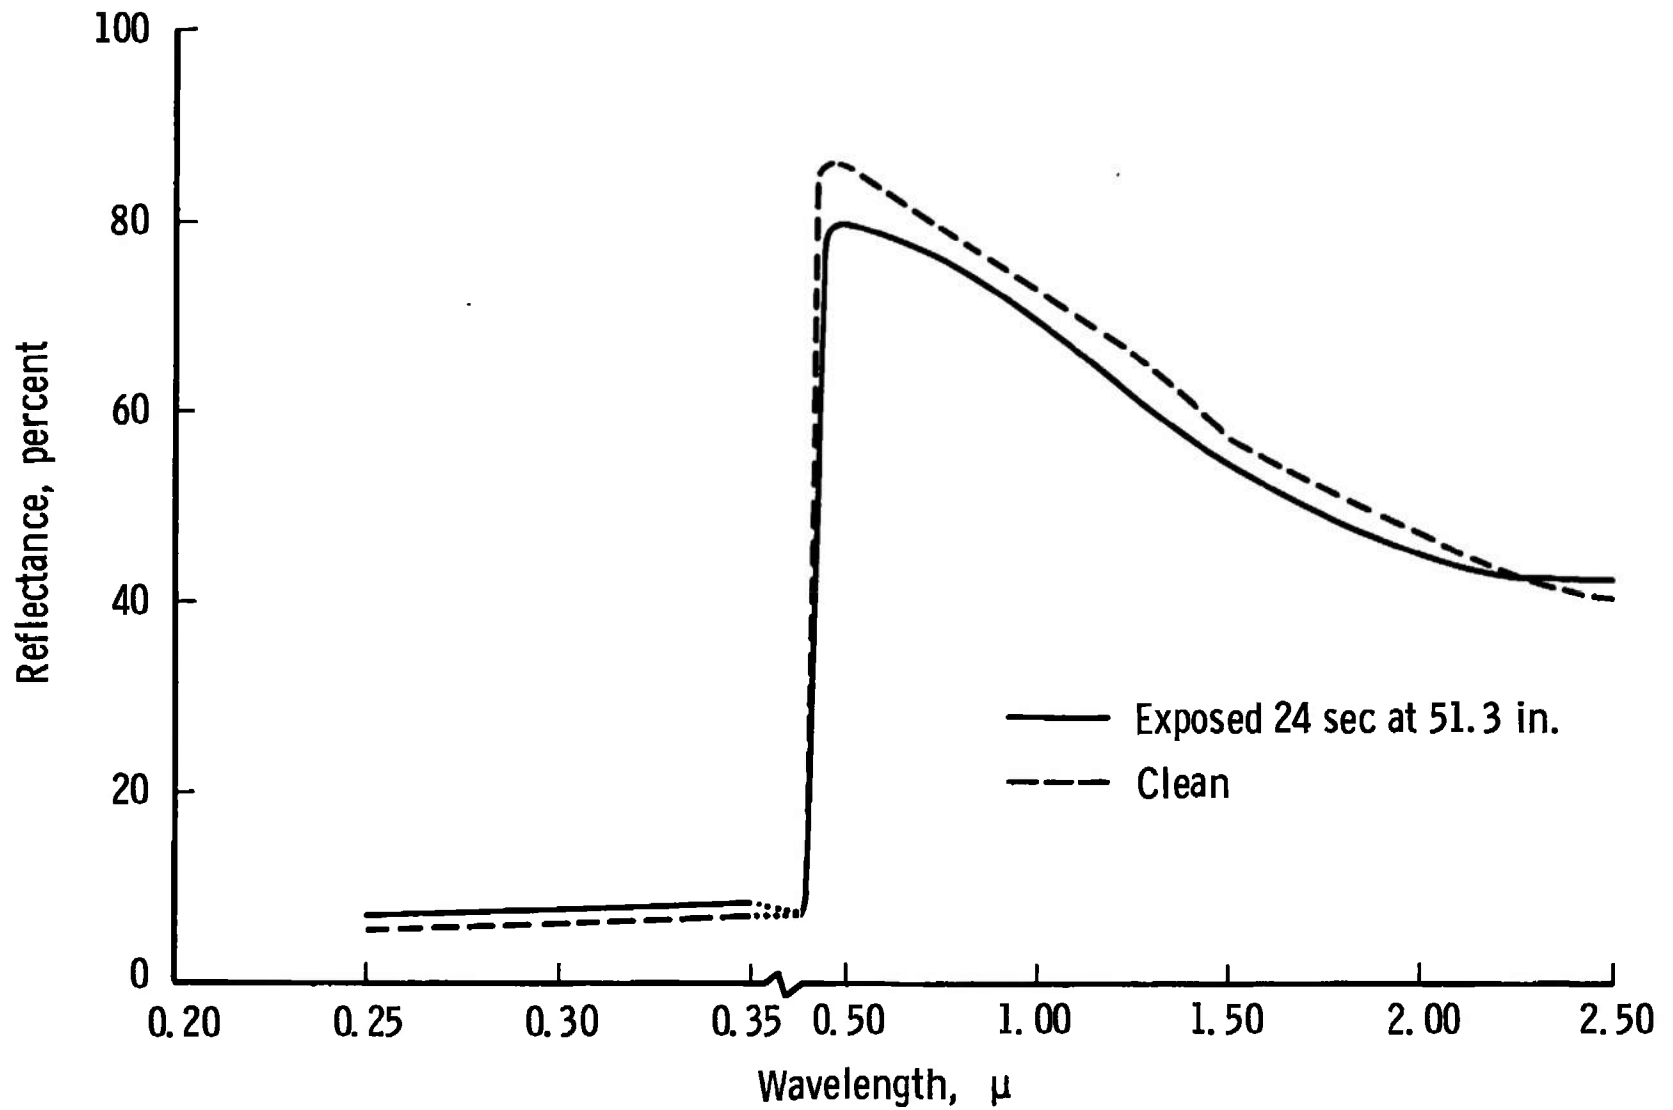
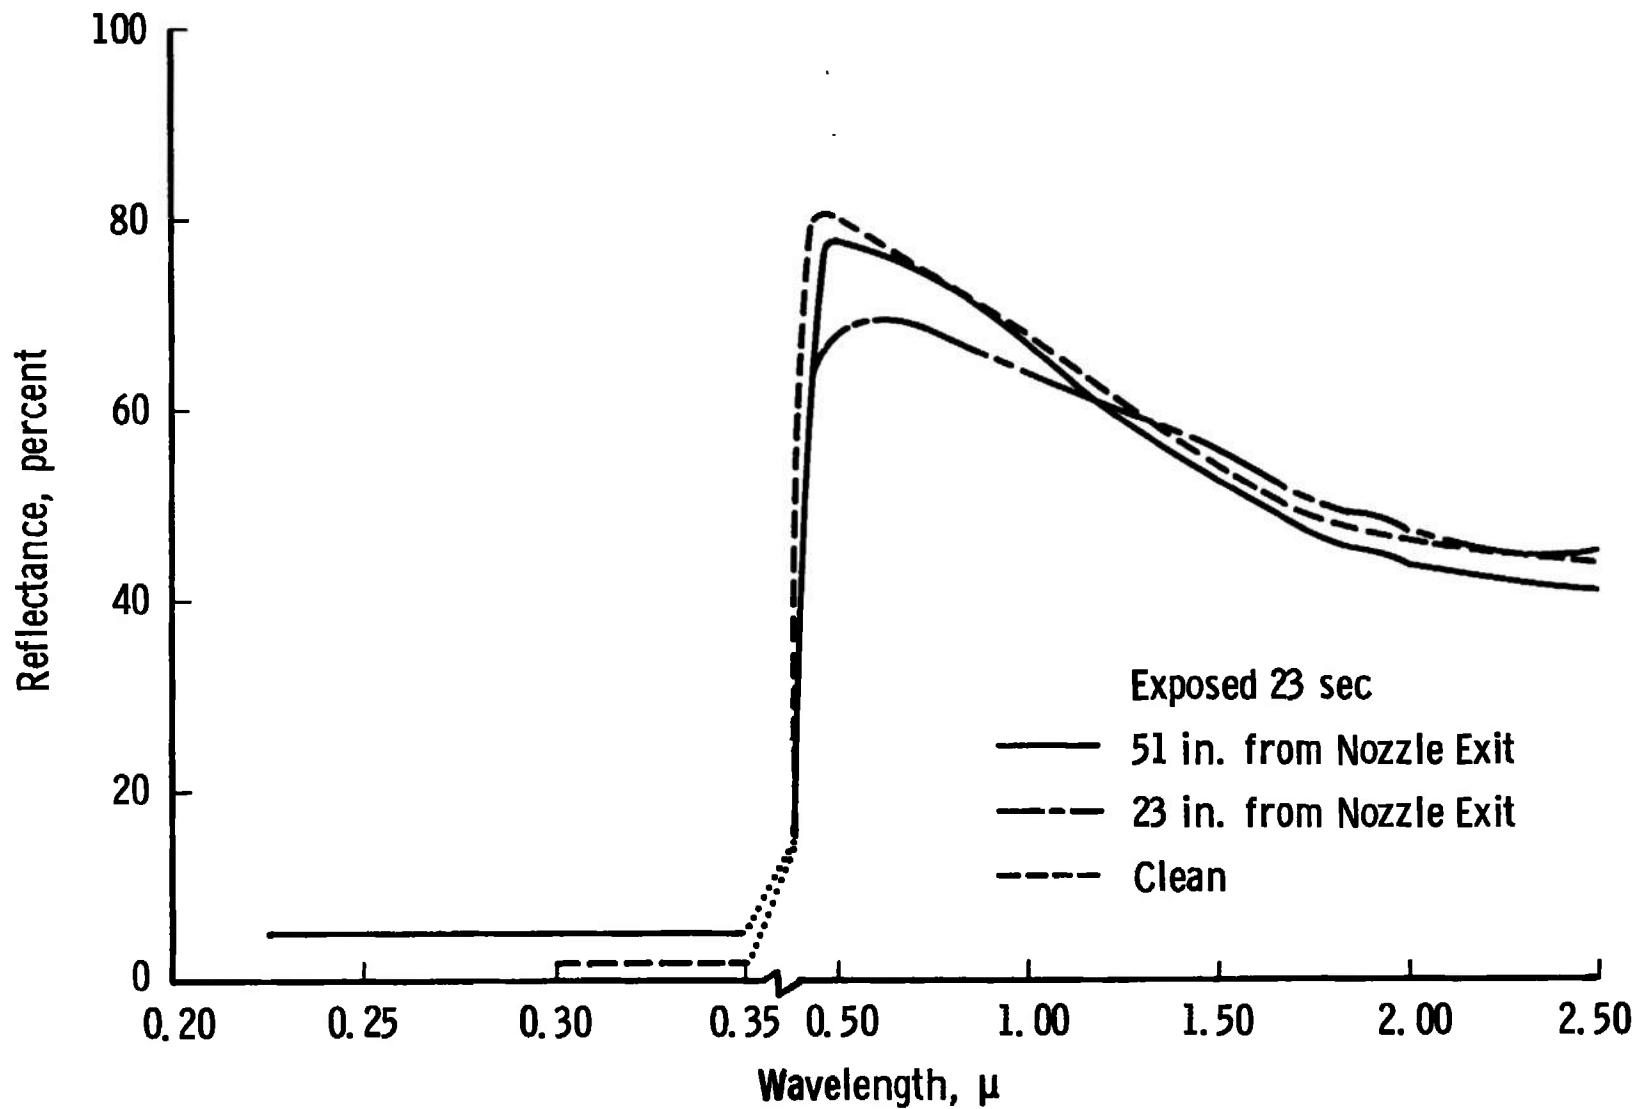
Reflectance data for the three thermal control coatings are presented in Figs. 22 through 27. There are two graphs for each coating: (1) a typical change after exposure to long duration firings, and (2) the changes after exposure to pulse firings. The reflectance data changes caused by contamination were used to calculate the corresponding effect on the solar absorptance. The solar absorptance change listed in Table III is indicative of change in the ability of the thermal control coating to function in controlling thermal heat loads.

The thermal control coatings exposed to long duration firings had reflectance changes of less than 10 percent over most of the 0.25- to 2.5- $\mu$  range. The largest reflectance change was experienced by the LP40A sample in the wavelength range from 0.28 to 0.45  $\mu$  as shown in Fig. 22. The maximum solar absorptance change for AL2082 and Z93 were 11 and 17 percent. The large reflectance change from 0.28 to 0.45  $\mu$  for LP40A caused the solar absorptance to change as much as 46 percent.

The thermal control coatings exposed to pulse firings had decreases in reflectance of from 10 to 20 percent over most wavelengths. The solar absorptance change was as much as 146 percent. The largest solar absorptance changes of 83 percent for Z93 and 146 percent for LP40A would be detrimental to their design function of controlling heat loads. The decrease in reflectance and solar absorptance for pulse exposed samples varied inversely with distance. These decreases were primarily caused by changes in reflectance below 0.7- $\mu$  wavelength. The decrease in reflectance for Z93 and AL2082 is accompanied by a shift in the reflectance cutoff wavelength.

Sample exposures accumulated from pulse firings (0.0225 sec) caused decreases of reflectance and transmittance of from 6 to 20 percent. In the wavelength range from 0.25 to  $2.5\mu$  the transmittance, reflectance, and solar absorptance decreased inversely with the distance from the engine. The infrared reflectance of the mirror samples experienced both decreases and increases. The change of infrared reflectance varied directly with the distance from the engine. Surface damage was experienced by the mirror surfaces directly in front of the engine exit during pulse operation. The maximum decreases in solar absorptance for the thermal control coatings were: 25 percent for AL2082, 83 percent for Z93, and 146 percent for LP40A.
